# Five Case Studies on the Effects of the SWANCC and *Rapanos* Supreme Court Rulings on Colorado Wetlands and Streams

Author: Dennis Buechler  
February 2010

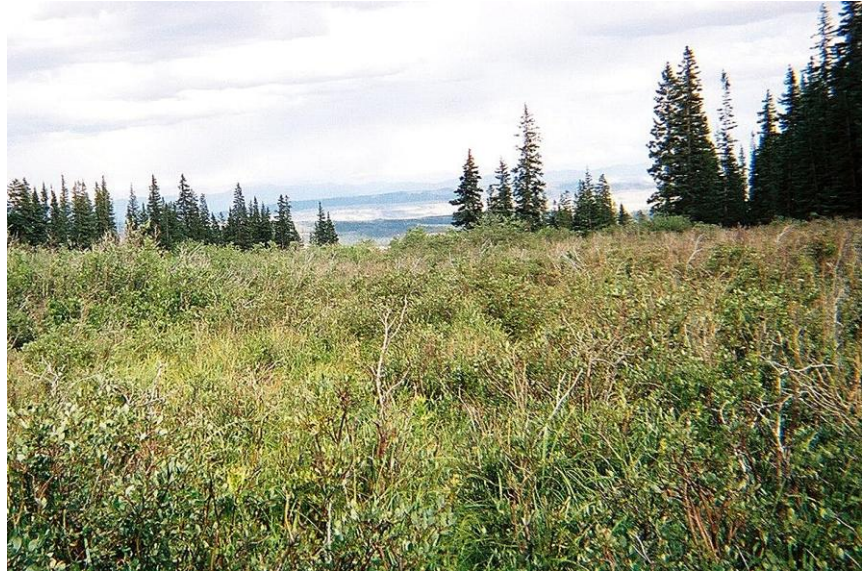
The author inspected this site on August 17, 2009. It is located in Park County about 6 miles northwest of Fairplay, CO. The Corps jurisdictional form (NOW-2008-2554-DEN) notes that this is an "...unnamed peat fen wetland (12 acres)..."

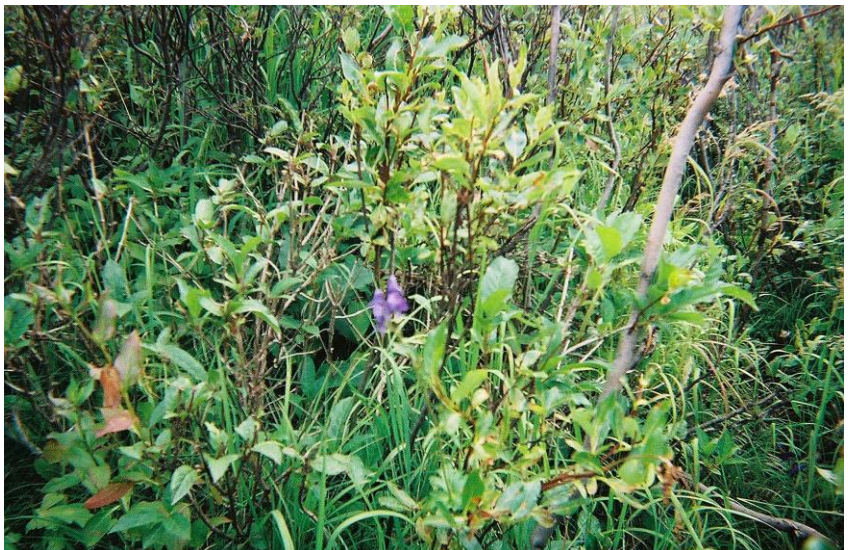
During the field inspection, the features of the site were consistent with a fen. The dominant plant species in the fen were willows such as *Salix planifolia* (planeleaf willow), *Salix monticola* (mountain willow), *Salix brachycarpa* (short fruit willow), *Carex aquatilis* (water sedge), and *Calamagrostis canadensis* (Canada reed grass). Other plentiful species included *Scenecio triangularis* (butterweed), *Carex utriculata*, *Caltha leptosepala* (marsh marigold) and *Aconitum columbianum* (monkshood), which is the purple flower in the photo above. The dominant species were those commonly found in the planeleaf willow/water sedge shrubland plant association described by the Colorado Natural Heritage Program. There were numerous tracks of elk, deer and bear in the area, and the area is heavily used for nesting songbirds. It is also excellent habitat for amphibians.

The soils were dark (note photo), peaty and highly saturated with standing water in some areas even though the terrain was sloped. It was so wet that no trees were sustained in that habitat. Note the thick lush growth of willows, sedges, and Canada reed grass in these photos, which were taken in mid-August. The average height of the willows was around 5 feet. While no detailed soil analysis was completed, it is quite likely that the Corps correctly identified this area as a fen wetland.

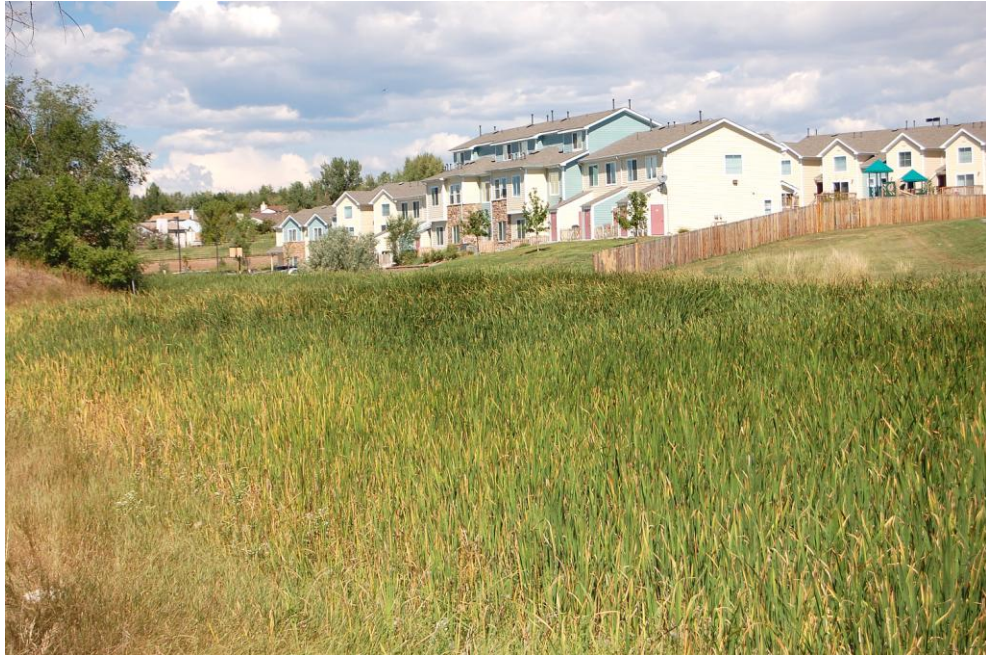
Picture on right: unnamed wetland drainage as it appeared in 2009.

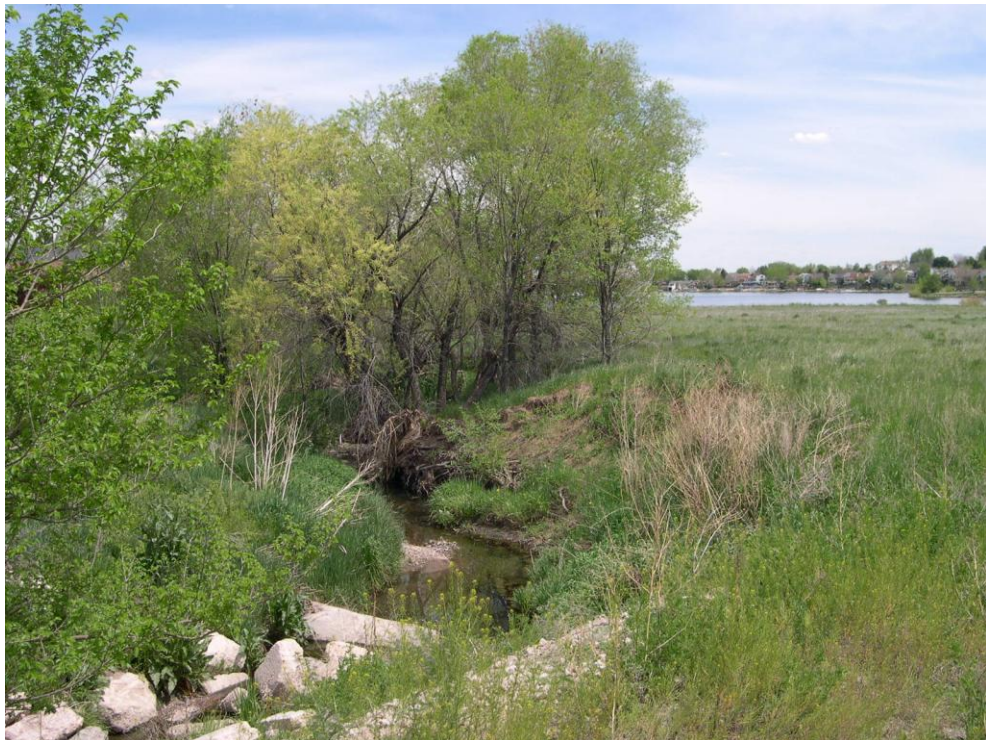
Picture on right shows flows from the wetlands in the above photo to the lake taken in May of 2005, but nothing was changed when observed in 2009.

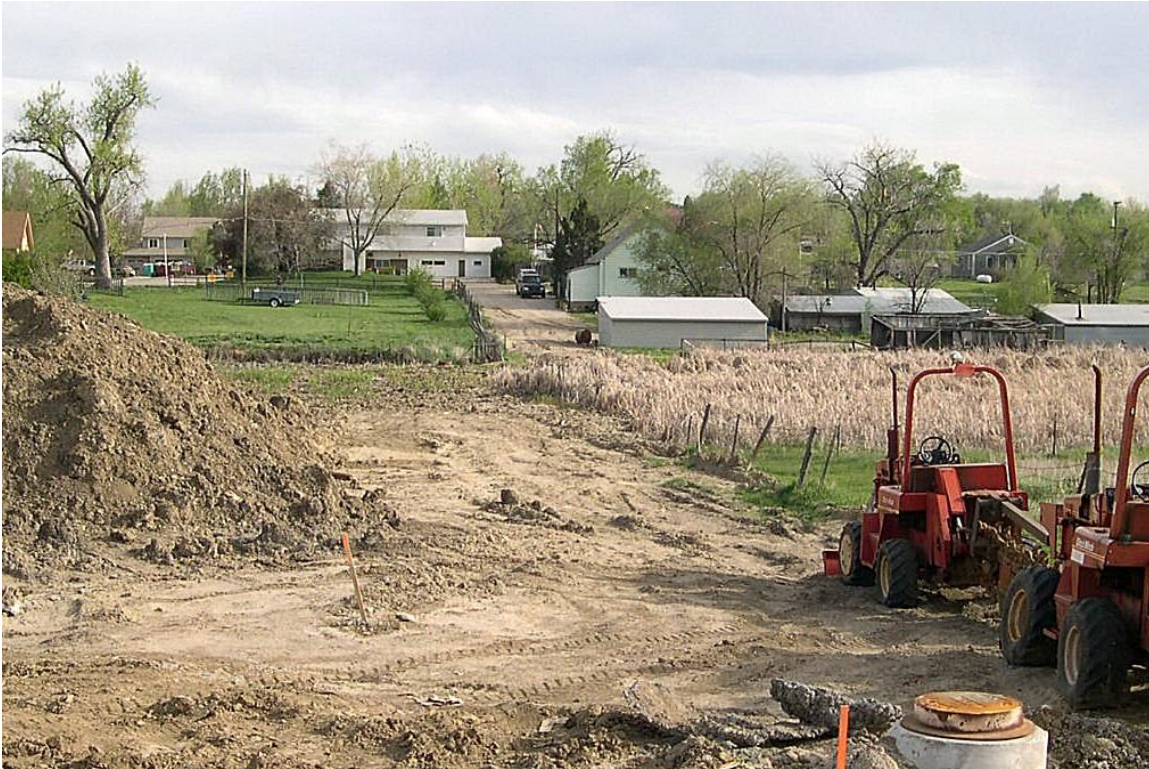
At the request of NWF, the author visited this site on May 10, 2005. At that time, he noted that housing construction had begun and was encroaching into the wetlands northwest of the intersection of 49<sup>th</sup> Ave. and Sheridan Blvd. (below). At least one acre of wetland had already been destroyed or degraded. The investigator, who is a wetland ecologist, noted mucky soils and a faint hydrogen sulfide odor, which attested to the maturity of this wetland. He also confirmed that discharges from the wetlands continued to flow into the lake as shown in the previous picture.

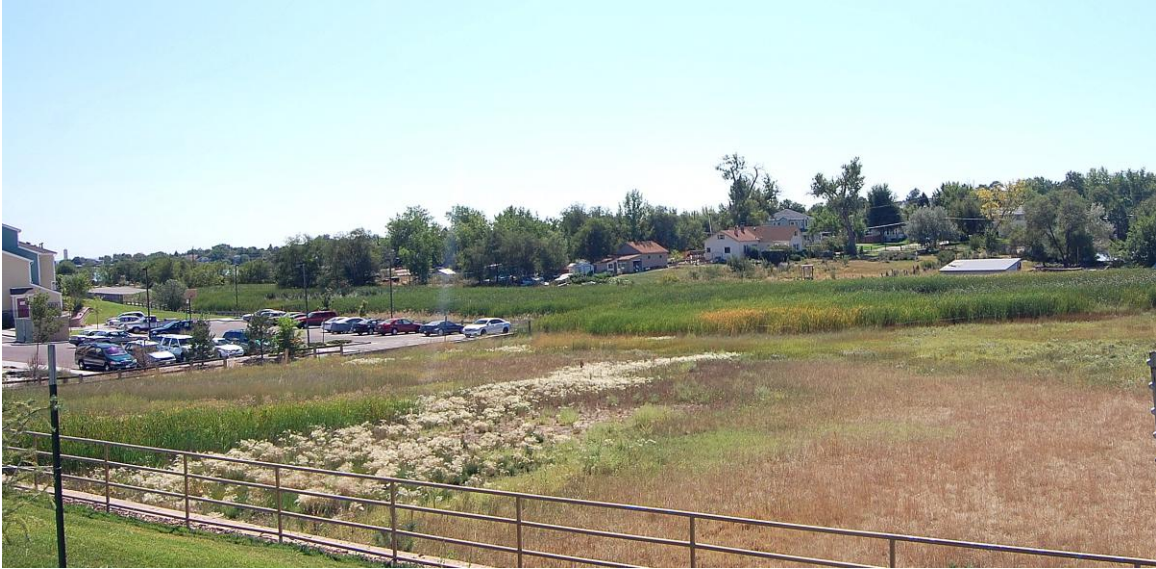
The author visited the site on September 7. Most of the wetlands that were present in 2005 were still there except for that portion that had been eliminated by construction of the lower parking lots (photo below). The dense cattails are important for absorbing nitrogen and phosphorus coming from residences with horse corrals that lie to the west and upslope in the drainage.

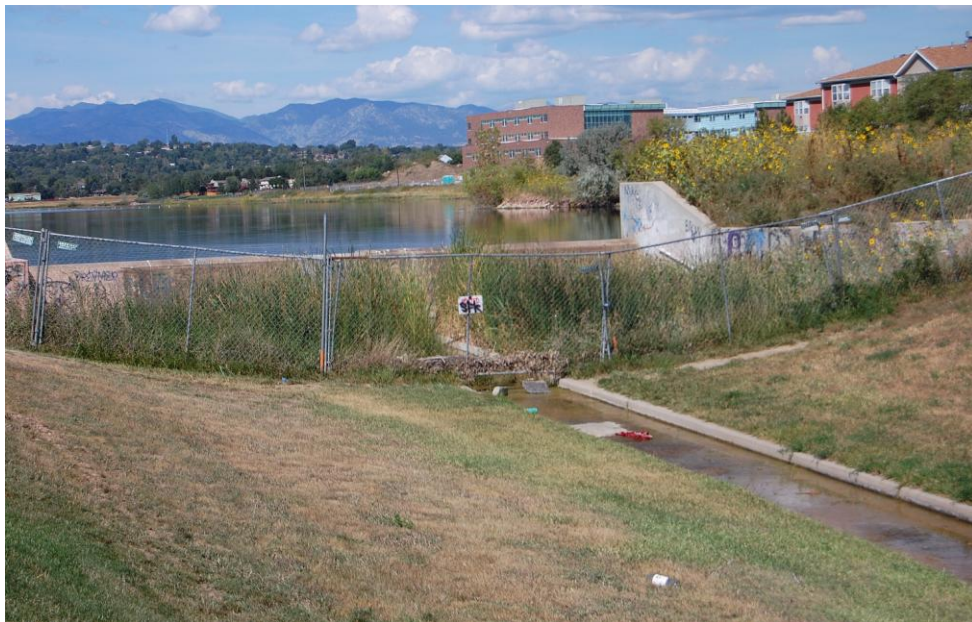
The author also inspected the spillway. The water was only a few inches below the top of the spillway, which seemed to confirm the statement by the City Engineer that overflows are not uncommon. Also, note the aquatic vegetation below the spillway overflow and the water that continues to leak into the channel. Therefore it can be assumed that a connection to Clear Creek still exists.

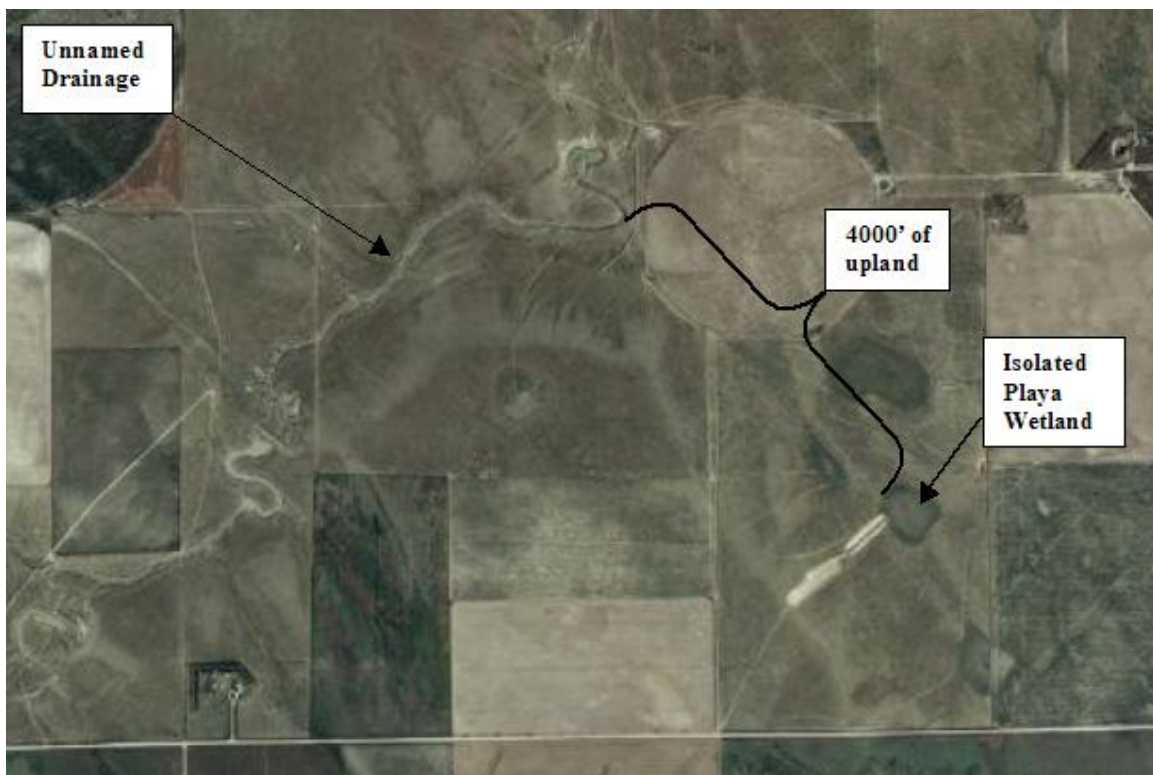
The Corps filed its non-jurisdictional decision for this playa on October 5, 2007. The activity that triggered the jurisdictional call was a proposal by USGS to check the area for a fault line, but they did not find one. They dug a trench 15-20' deep. However, they may not have refilled it, perhaps to promote drainage of the wetland, because it can be seen on the aerial photo below, which was copied from the Corps file NOW-2007-2709-DEN.

The Corps' non-jurisdictional decision was based upon their findings that "The 8 acre playa wetland in question is isolated and completely surrounded by upland. It is located approximately 4000 – 5800 feet from any potentially jurisdictional tributary. There is no evidence that any surficial flows ever leave this isolated wetland." Their form also notes that prior to the 2001 Supreme Court decision in "SWANCC", the area would have been regulated solely based upon the "Migratory Bird Rule".

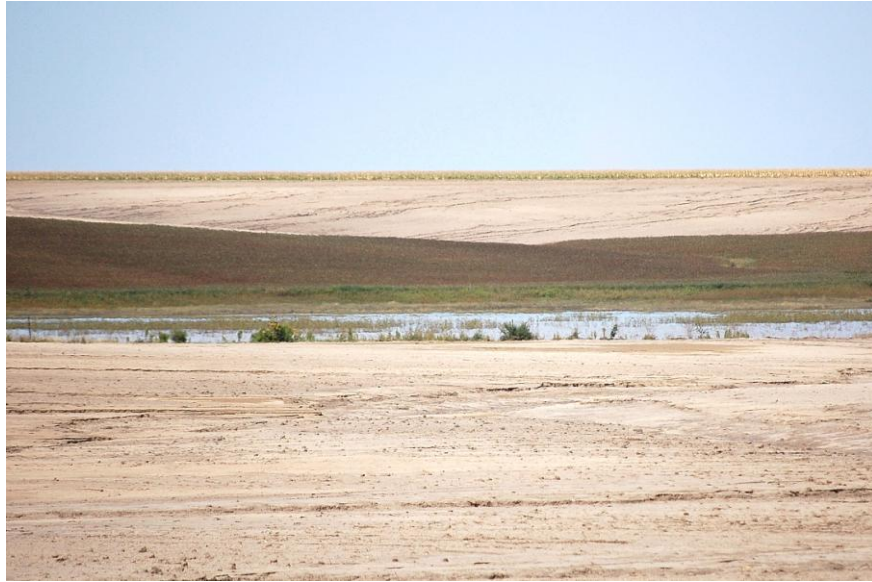
However, it was apparent that the USGS trench did not result in effective drainage of the playa. As the photo below demonstrates, it was vegetated and filled with water when the author visited the site. The photo was taken from the road shown on the bottom of the photo above.

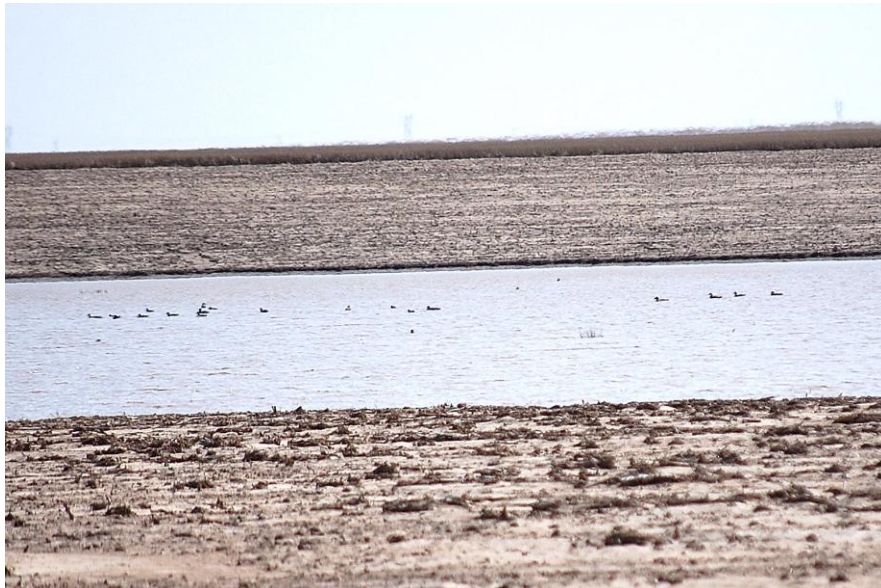
The photo below of a similar playa about ¼ mile south of the road demonstrates the value of these wetlands. When the subject site was visited by the author, it was being used by at least forty ducks, mostly blue-winged teal. It is also obvious in these photos that many of these playas are surrounded by intensely cultivated agriculture land. Therefore, they provide an oasis of habitat in the semi-arid plains. However, because they are usually geographically isolated, the Corps probably does not take jurisdiction over playas in most cases.

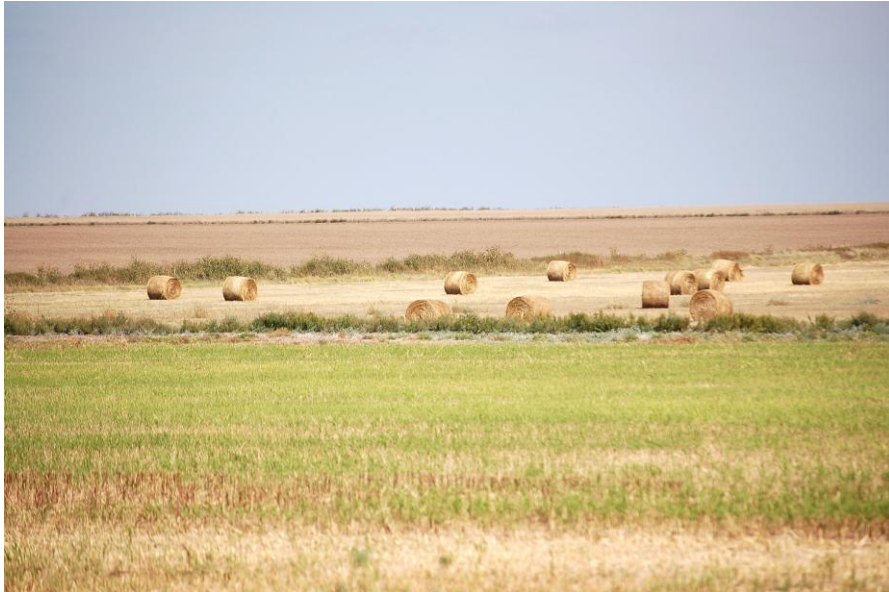
As can be seen in the following photo, some playas also provide hay and forage benefits to farmers and ranchers in the area. The landowner was able to harvest several large bales of hay from this playa.

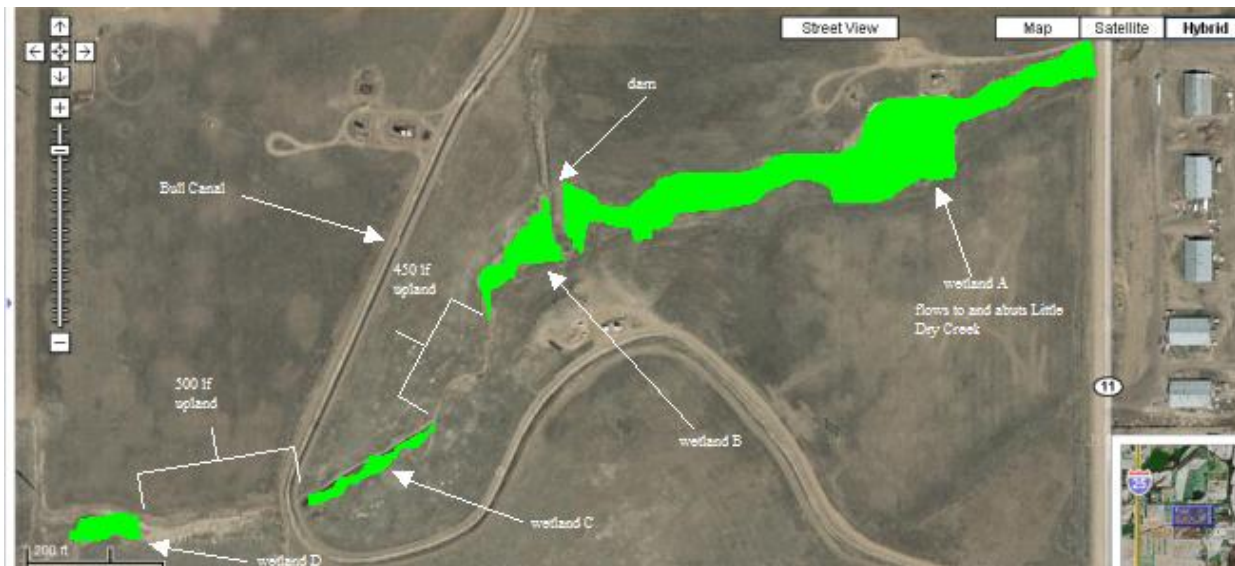
The author visited this site on September 15, 2009. It is located near St. Vrain, CO, which is just a short distance east of the Erie exit (232) on I-25 and near the junctions of C.R. 11 and C.R. 6.<sup>3</sup> Below is a photo copied from Corps file number NWO-2007-1849-DEN, which has four wetland sites identified.

The form on page 2 states, “Based on recent site visits, it was determined that Wetland A is surface connected and flows off-site to Little Dry Creek (not in review area), an RPW.” On page 3 it states, “Wetlands B, C and D are located on an isolated drainage that flows to a historic pond dam. These wetlands are separated from Wetland A by the historic pond dam where there is no evidence that water flows over or around the dam.

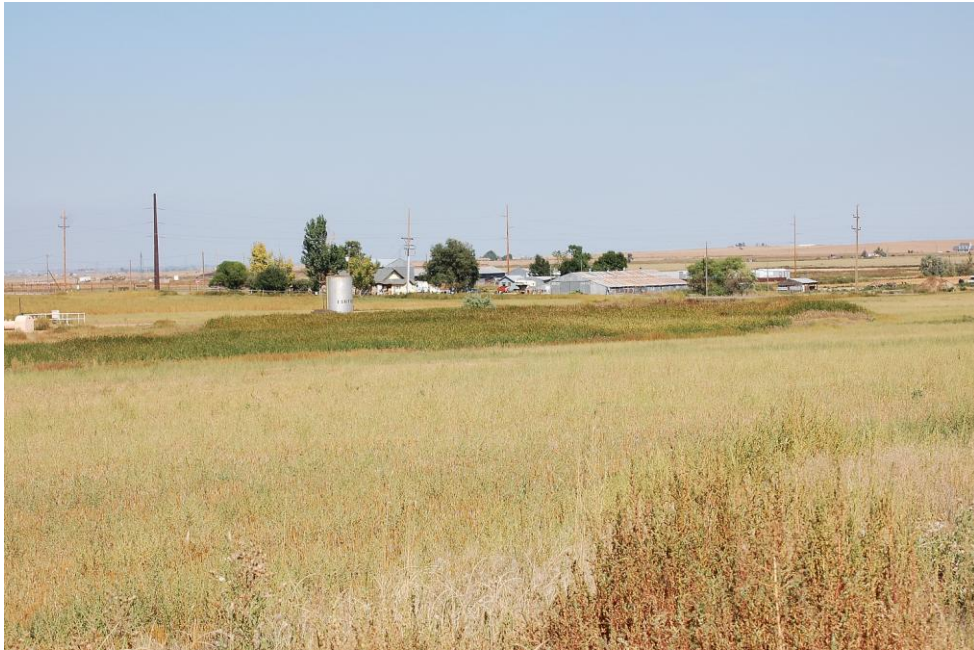
The site visit verified that Wetland A appears to be a high quality, fully functional wetland that drains into Little Dry Creek.

Wetlands A and B are separated by a low-level dam, which is located in the small light green trees shown just to the right of the oil tank in the photo above and in the center of the photo on the next page. This dam bisects what historically was a string of wetlands stretching for about 1/2 mile upslope from wetland A and appeared to have served as a means of crossing the drainage during wet periods. Some ponding probably occurs intermittently in Wetland B, which the Corps estimated to be 0.26 acre, but there did not appear to be any ponding during the site visit. Furthermore the only cattails were those immediately adjacent to the dam so the actual wetland acreage appeared to be much less than the acreage estimated by the Corps.

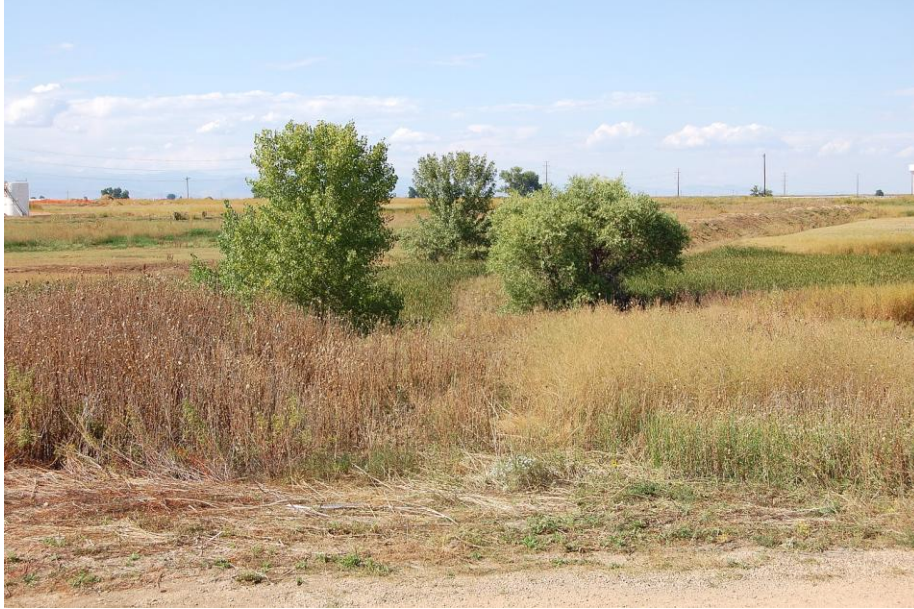
In the photo above, Wetland A is to the right of the trees, the small dam is the light colored vegetation in the center of the two nearest trees, and Wetland B is adjacent and to the left of the dam. Wetland C in the photo below is linear and quite small. It was estimated by the Corp to be 0.06 acre. It looked healthy, however, and thus provides wildlife habitat. As indicated by the Corps, it probably is dependent on flows from wetland D that travel through a culvert underneath Bull Canal (see Corps site photo).

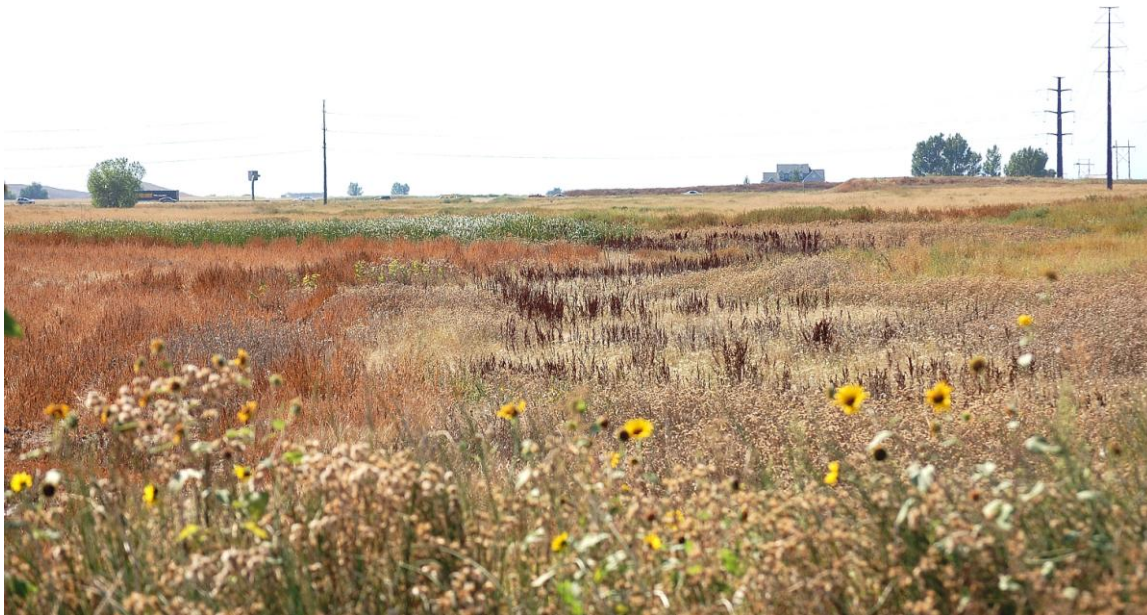
The basis for the Corps estimate of the size of Wetland D (see photo on next page) is unclear. There appeared to be a string of interconnected wetlands stretching upslope from the canal with a total acreage of much more than the 0.31-acre listed by the Corps. For example, the area in the center, which drains to the northeast from the cattails toward Wetland C, appeared to the author to be temporary wetlands not upland as

labeled in the Corps site photo. The dark plants in the middle of the photo are veiny dock (*Rumex venosus*), which is a hydrophytic plant. Therefore, without other data such as soils reports and vegetation sampling, the author concluded that the acreage estimate was only based upon the cattails.

Wetland D and the other adjacent upslope wetlands also appeared to be functional and to provide good quality habitat for migratory birds, small mammals, and perhaps fawning deer. While their water quality functions probably no longer provide benefits to Little Dry Creek, they likely have retained other wetland functions with regard to ground water recharge and retention of flood flows during precipitation events.

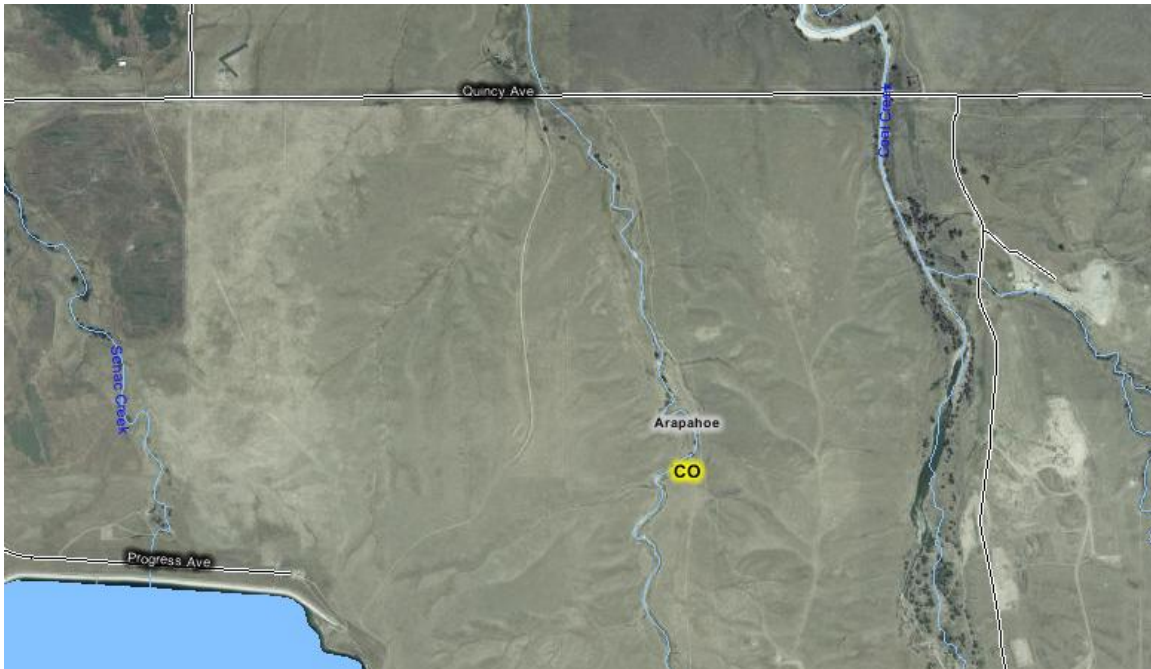
The Corps' form includes the following statements on the first page: "The aquatic features of Black Shack Creek are located approximately 1 mile up-gradient from the non-RPW [relatively permanent water] and closest waters of the U.S., Coal Creek. The OHWM [ordinary high water mark] of Black Shack Creek is disconnected from Coal Creek by approximately 1 mile of upland. Black Shack Creek does not have a significant nexus to a TNW [traditional navigable water]." On page 3 it states, "There are no indications the normal flows (or even high flows) in Black Shack Creek make their way to Coal Creek." However, both the USGS topo map and the map used on the Web Soil Survey (see below) show this creek, located at the yellow-highlighted "CO", as a solid blue line with no breaks from the creek to its junction with Coal Creek.

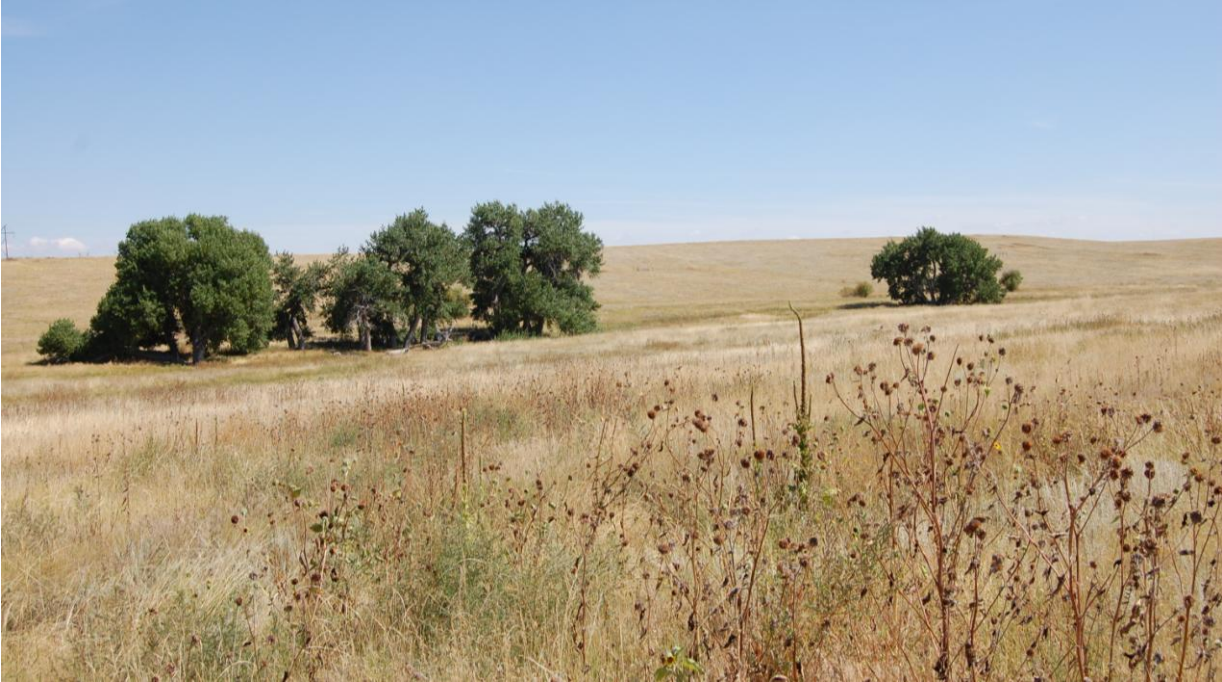
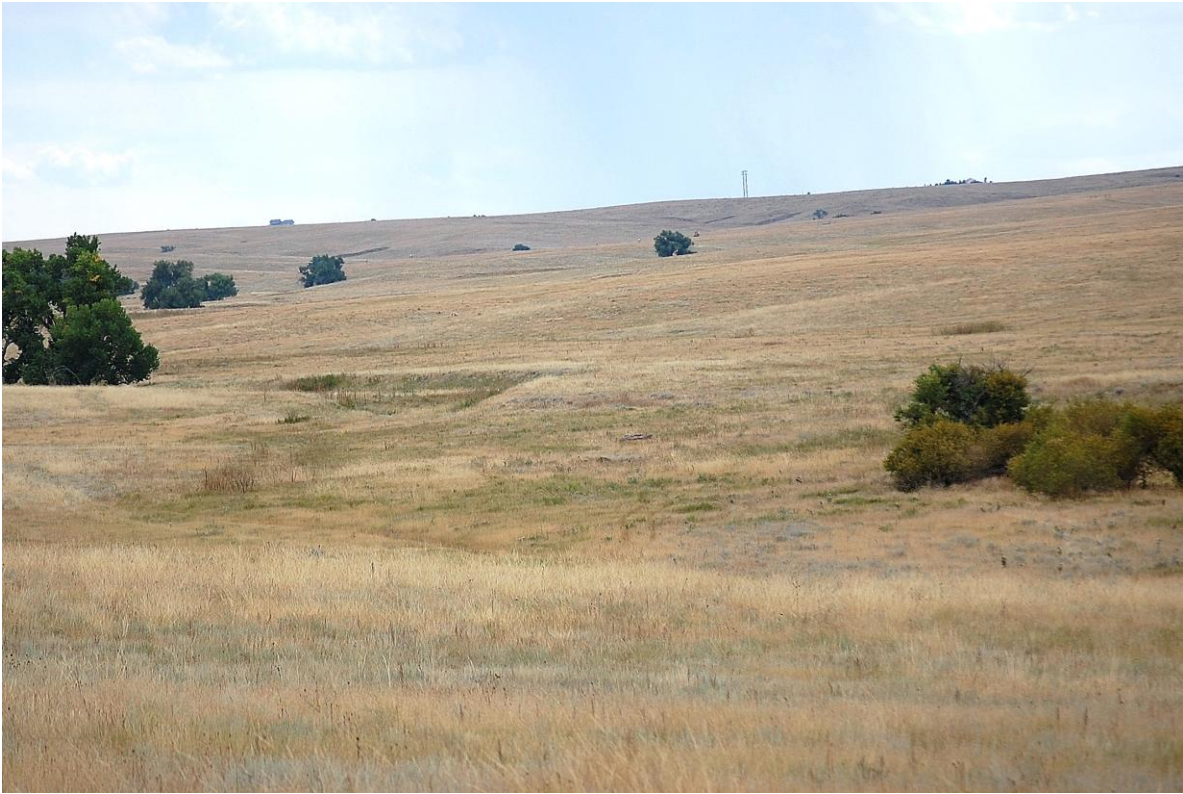
The first photo below is the approximate downstream end of the project (note color of grasses by the trees). The second photo is further down slope and about a half mile upstream from Coal Creek.

Whenever flows do reach Coal Creek, it is via the grassed waterway, which can be readily seen as the curved greener section in the middle of the above photo. Unless they otherwise demonstrate wetland characteristics or demonstrate characteristics of a tributary, grassed waterways have historically not been regulated as “waters of the United States” under the Clean Water Act. However, they often serve as important links between protected waters and demonstrate connectivity between such waters.

The grassed waterway shown in the above photo likely would not be delineated as a wetland under the Corps 1987 manual even though the tree layer is dominated by smooth-barked and plains cottonwoods. However, from a hydrological and biological standpoint, the presence of this grassed waterway combined with the tree species demonstrates a strong potential linkage between upstream waters and downstream waters. Those tree species are common in the eastern plains and are classified as hydrophytic (i.e., water loving) plants. They are typically found along streams and ephemeral waterways that have relatively high water tables and/or are frequently flooded.

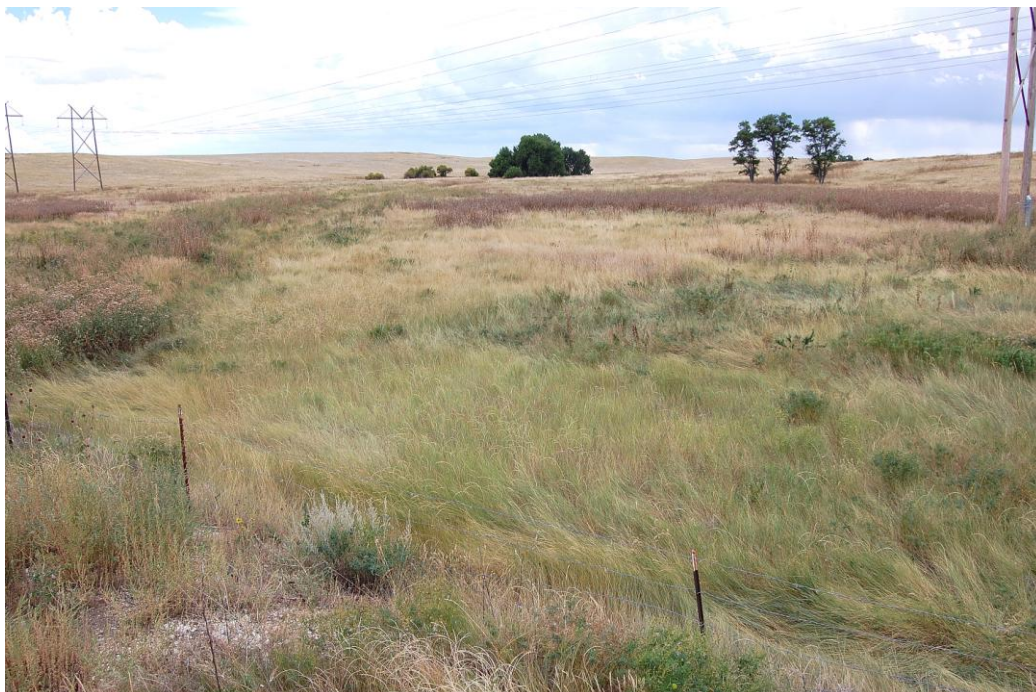
Notice the flattened grass in the below photo shot SE and next to the bridge on Quincy Avenue, which is 3.7 miles east of the junction of this road and Gun Club Road. The grass also is light green, more slender than on healthy western wheat grass, and has not headed out, despite the fact this picture was taken on September 14, 2009. Western wheat grass can normally tolerate short periods of inundation and saturation. Therefore, the stressed growth and flattened shape indicates a substantial amount of water runs through this drainage intermittently. Many of the plant species that can be seen upstream from the grassy area are common at sites influenced by water. They are significantly different than the native prairie grasses that border the drain.

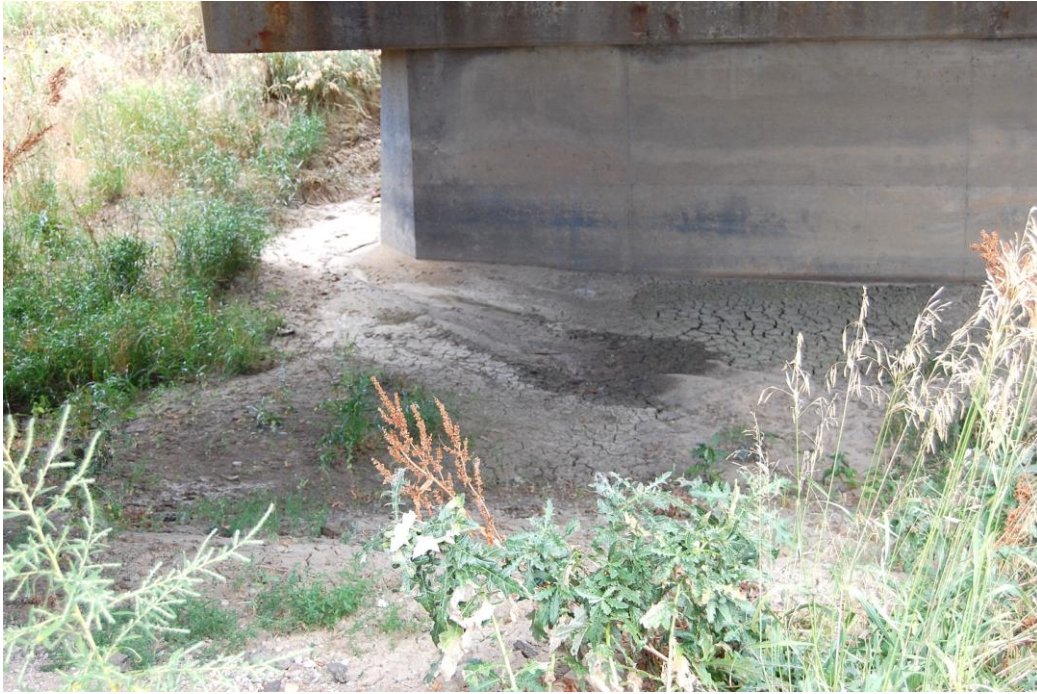
Recent high flow activity also was reflected in the area under the bridge because it was highly scoured and muddy on September 14, 2009 (see photo on next page).

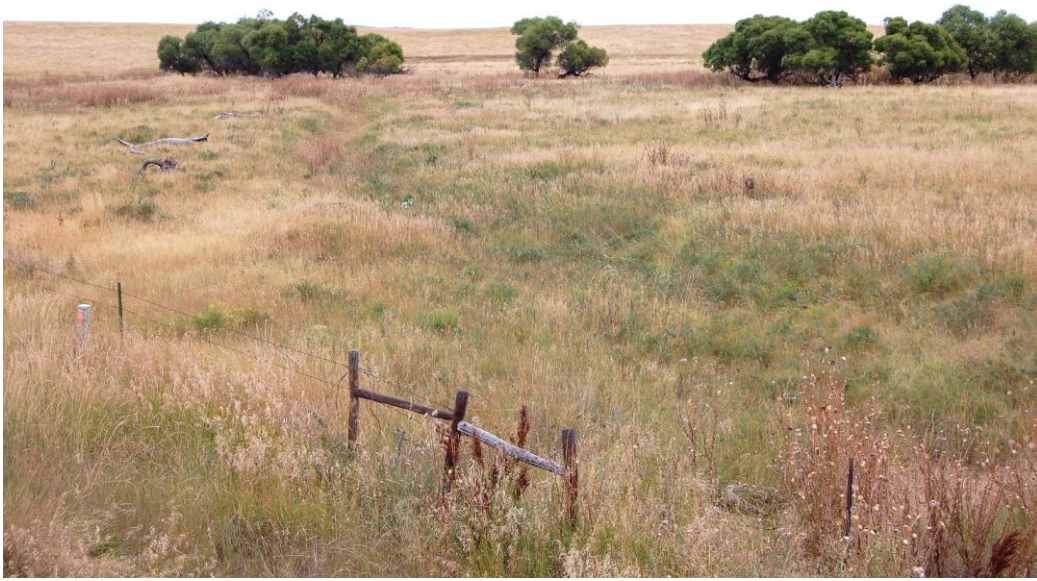
The following photo was shot NW from the bridge. At the tree line, the waterway turns right (north) toward the junction with Coal Creek. Note the defined waterway and how green the vegetation is compared to the surrounding area.

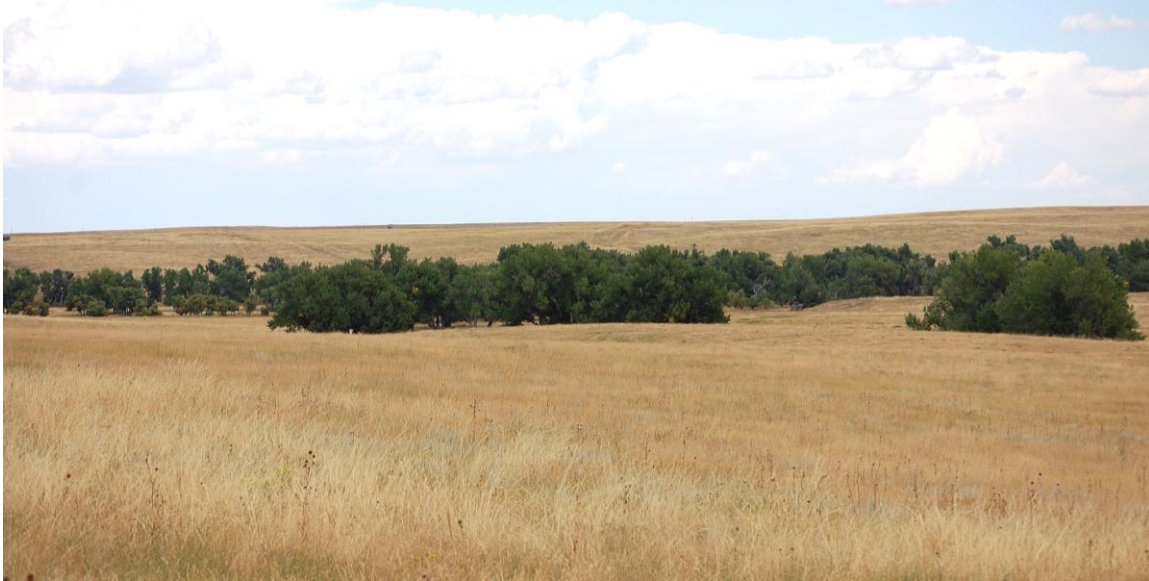
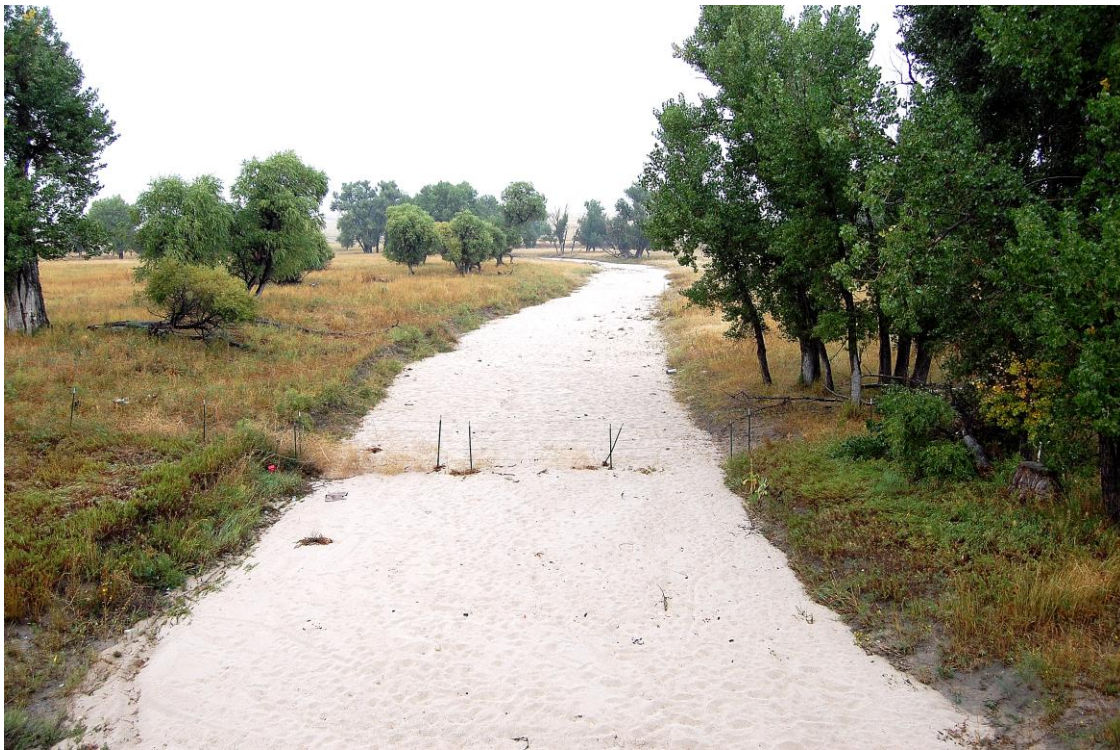
Below is a photo of the junction of the Black Shack drainage and Coal Creek. The second photo is of Coal Creek upstream from this junction. The riparian woody habitat along these draws is extremely important for songbirds, raptors, fox squirrels, whitetail deer, northern bobwhite quail, mourning dove, turkey, and many other species. Drainages with ephemeral flows like these two creeks are where native trees are typically found in the semi-arid plains.

The section of Coal Creek shown in the photo above is less than ½ mile upstream from the junction. It was taken shooting north from the bridge over Coal Creek that is about ¼ mile east of the bridge over Black Shack Creek. Note the bed is dry sand, which would enable the moisture from regular rain events to drain easily. However, the bed and bank are very established, and there is little or no vegetation in the channel because of scouring from high flows.

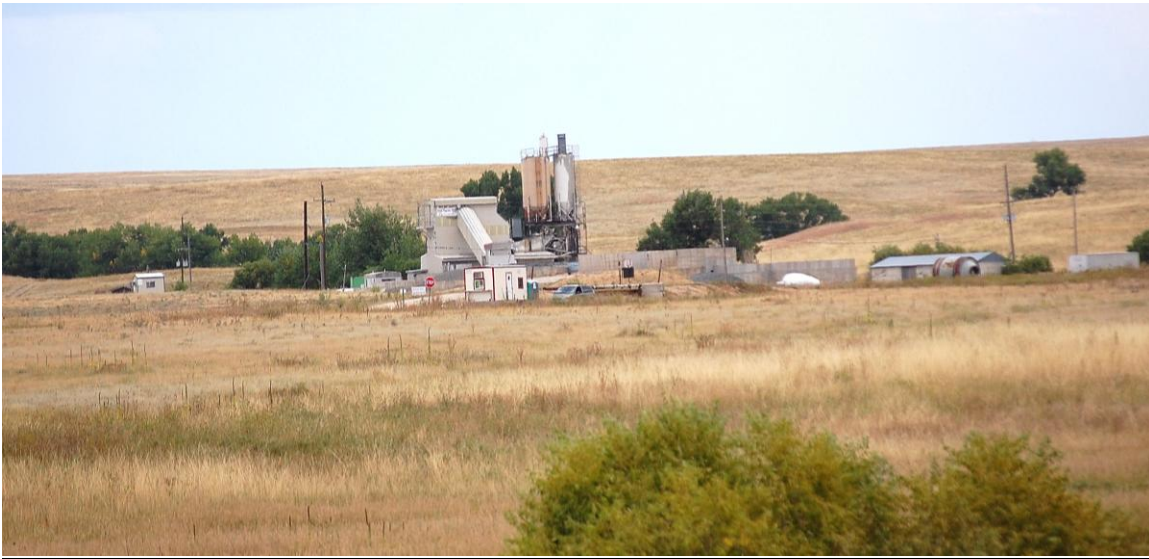
The last photo shows an industrial site (e.g., sand mining) located in the floodplain of Coal Creek drainage just ½ mile upstream from the bridge on Quincy Avenue. Furthermore, a new subdivision is being built just a couple of miles to the southwest. These important ephemeral streams are threatened by development and should be protected.
